District Department of Transportation

Speed Limit and Safety Nexus Studies for Automated Enforcement Locations in the District of Columbia

East Capitol Street at Benning Road NE

Study Area and Location

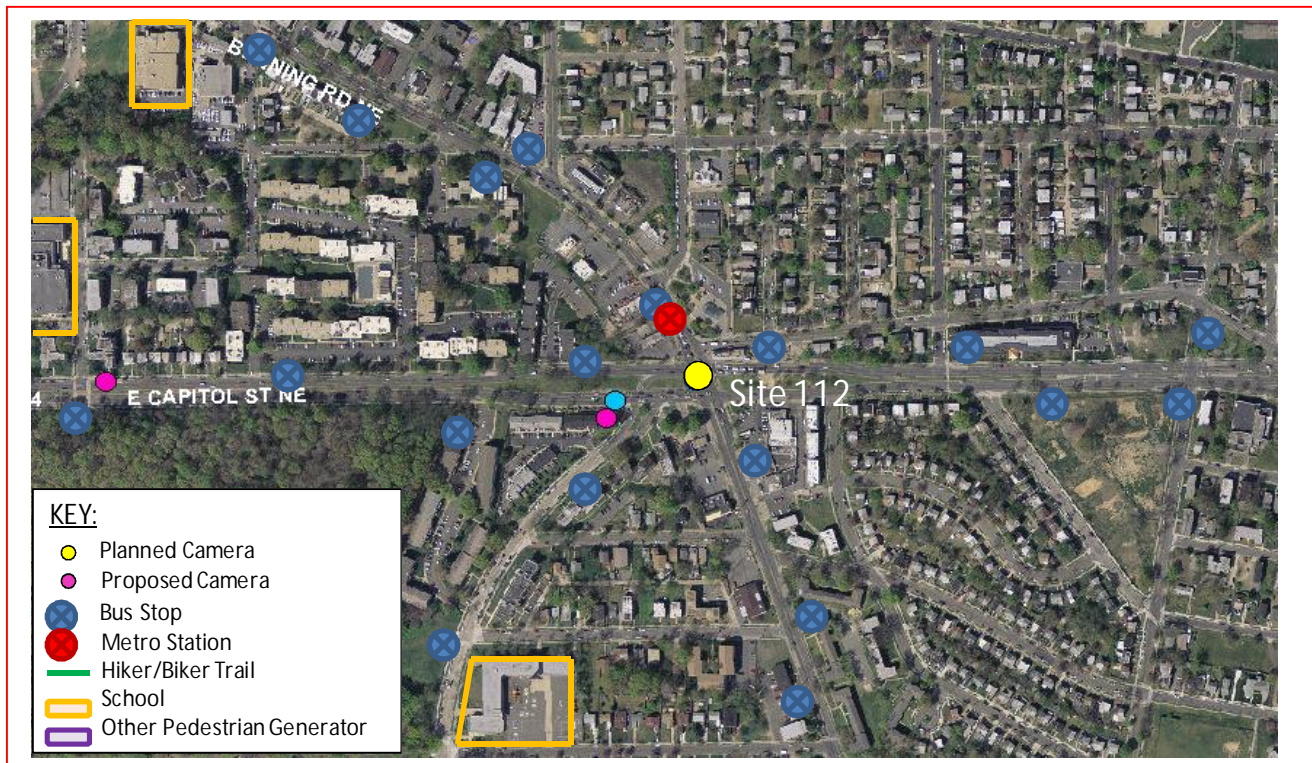
This *planned* speed camera will be located in Ward 7 at the intersection of East Capitol Street and Benning Road Northeast in the westbound direction. East Capitol Street runs between Southern Avenue Southeast to the east and C Street Northeast to the west. The posted speed limit is 35 MPH.

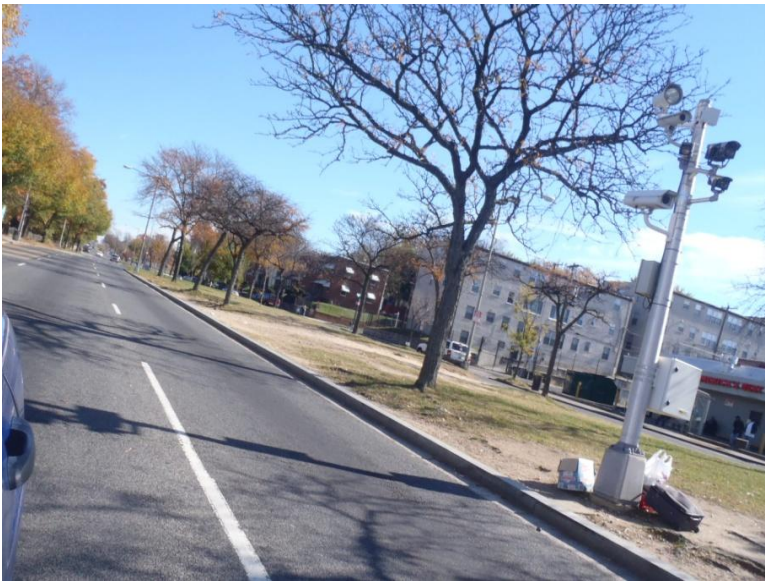
Looking Eastbound

East Capitol Street is assumed to run in an east-west direction, and is classified as a principal arterial. East Capitol Street has three travel lanes in each direction and a left turn bay eastbound on the west leg of the intersection. Benning Road Northeast has three lanes in each direction. One of the lanes in each direction of Benning Road Northeast is a left turn lane. This site has the following characteristics:

- This is a residential and commercial area with apartments and businesses.
- There are four schools in the area: Boys and Girls Club of America, DC Prep, Richard Wright Public Charter School, and Plummer Elementary School.
- The Benning Road Metro Station is in the northeast corner of the intersection.
- There is a concrete island in the center of the intersection and concrete medians on the north and south legs. There are grass medians on the east and west legs.
- There is sidewalk on both sides of all four legs of the intersection.
- The intersection has a traffic signal with pedestrian signals and crosswalks on all four legs.
- There are bus stops westbound on the east and west legs and eastbound on the east leg. There is another bus stop on the west side of the south leg.

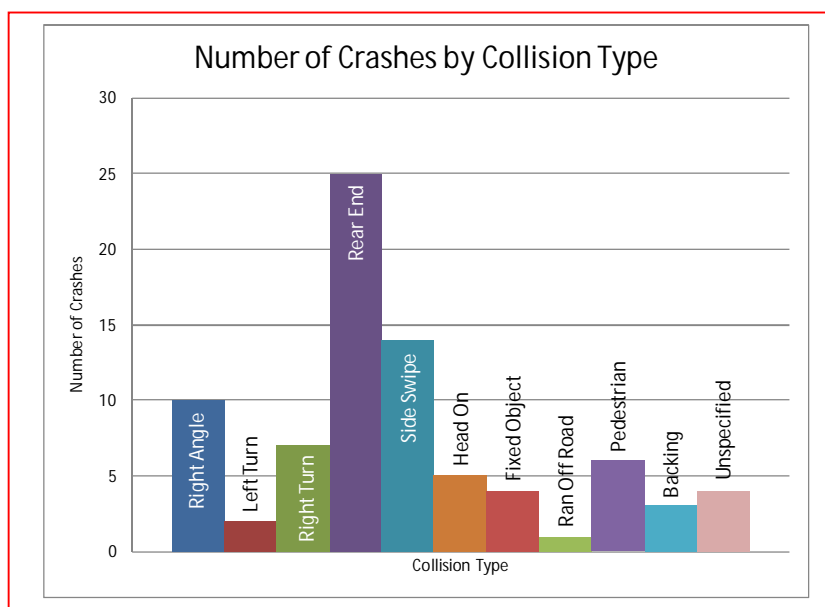
From the Accident Summary Report provided for the dates between January 1, 2010 and December 31, 2012, there were a total of 81 crashes at this location. A breakdown of number of crashes by collision type can be found in the chart on the next page. This location also experienced a high frequency of injury-related crashes. The most common types of crashes at this location were Rear End (25 crashes), Side Swipe (14 crashes), Right Angle (10 crashes) and Right Turn (7 crashes). The other collision types had six crashes or less each. Furthermore, this site experienced a high frequency (37 crashes) of injury-related crashes.

There were an elevated number of speed-related crashes at this location including Rear End and Side Swipe crashes. The *Highway Safety Manual* lists “assuming the lead driver will go through a green or yellow light, but the lead driver stops” and “changing lanes to avoid a slowing or stopped vehicle” as two errors leading to Rear End and Side Swipe crashes.¹ Both of these errors can be reduced with a decrease in travel speed.

1. Speed Data – The 85th percentile speed is higher than the posted speed limit at this location.
2. Crash Data – There was an elevated number of speed-related crashes including Rear End and Side Swipe collisions, as well as a high frequency (37 crashes) of injury-related crashes. The Benning Road Corridor is listed as one of the Top 10 high frequency crash corridors from 2009 to 2011. This intersection is listed as one of the Top 20 hazardous intersections from 2009 to 2011 and is listed in the Top 5 percent high accident locations in the District from 2010 to 2012.
