3 AFFECTED ENVIRONMENT

3.1 NATURAL RESOURCES

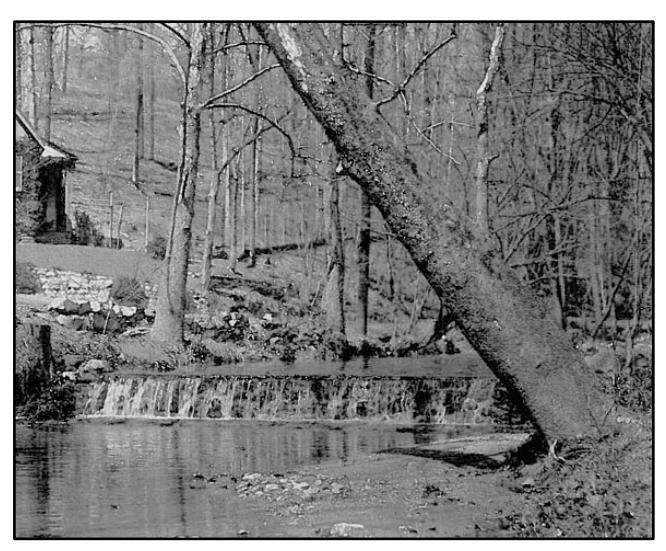
Based on historical photographs and park history, archaeological sites related to the establishment of Rock Creek Park and the enhancement of the Park with the construction of rural architectural features may occur. For example, a multi-course stone dam was constructed across Broad Branch north of the Soapstone Creek Culvert ca. 1898 to enhance the rural feel by creating a waterfall (Figure 3-4). Although evidence of the stone dam is no longer visible due to years of siltation at the confluence of Soapstone Creek and Broad Branch, archaeological remnants of the dam could occur. Fifteen segments of a historic stone retaining wall line the west side of Broad Branch in the stream bed; it is possible that the stone retaining wall may

Figure 3-4. Pre-1934 Photograph of the Stone Dam across Broad Branch (E. B. Thompson, D.C. Public Library Photo Archives)

have been continuous and through time, portions have been displaced or destroyed by stormwater. Although surface manifestations of the stone wall are lacking along portions of the stream, archaeological remains of the wall foundations could occur.

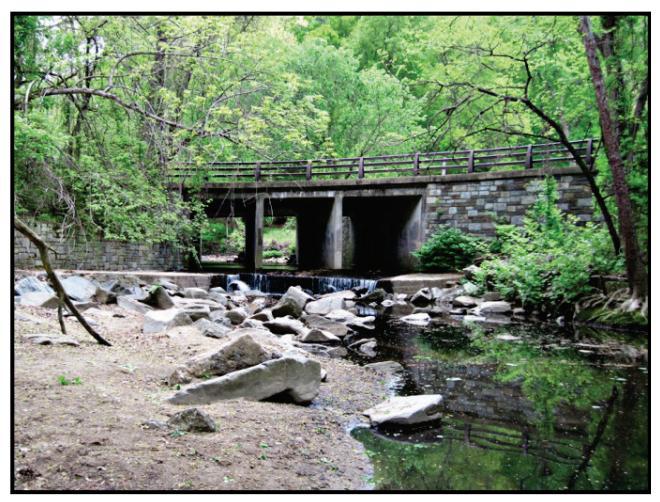
Figure 3-6. Broad Branch Creek Bridge over Broad Branch, looking north

The Broad Branch Creek Bridge over Broad Branch near Beach Drive (RCP-RPI 3450-7311) was constructed in 1957 and replaced the old ford that previously crossed Rock Creek. The bridge is a pre-stressed concrete girder bridge over a triple-span concrete box culvert with irregularly coursed stone veneered (gneiss) abutment and steel railing similar in design and materials to the nearby Glover (Ridge) Road Bridge (**Figure 3-6**).

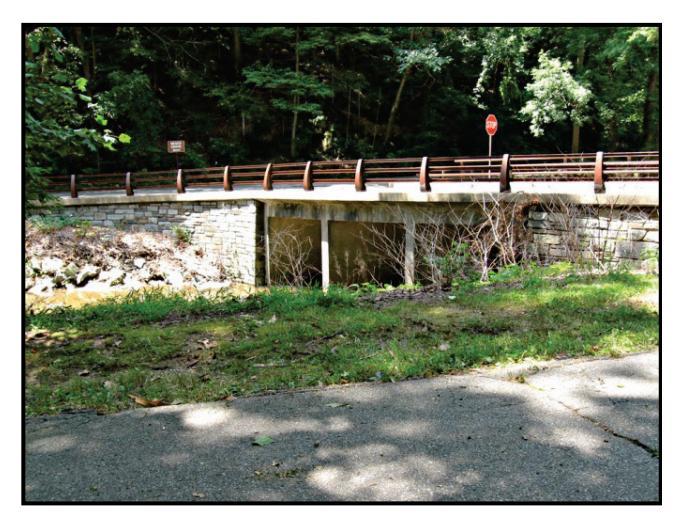
Figure 3-7. Glover (Ridge) Road Bridge over Broad Branch, looking west

The Glover (Ridge) Road Bridge over Broad Branch Run (RCP-RPI 3450-7312) was also constructed in 1957 and replaced the "Pebble Dash" Bridge that had carried Beach Drive over Broad Branch Run from 1902 to 1956. The bridge is a pre-stressed concrete girder bridge over a triple-span concrete box culvert, with stone-veneered (gneiss) abutments and steel railings similar in design to the Broad Branch Road Bridge (**Figure 3-7**).

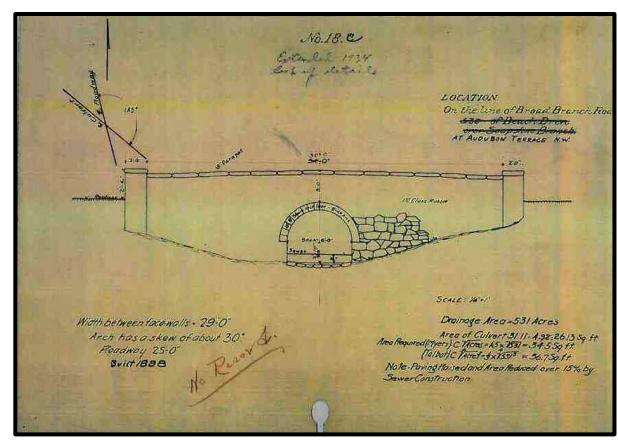
Soapstone Creek Culvert. The Soapstone Creek Culvert, located at the confluence of Soapstone Creek and Broad Branch stream, is a six-foot wide, stone arch culvert constructed in 1898 during a period of initial improvements to adjacent Rock Creek Park (**Figure 3-8**). The downstream wing walls were most likely added in 1934 when the culvert was extended (**Figure 3-9**).

Figure 3-8. Soapstone Creek Culvert (1898 – DDOT Archives)

Prominent features of Soapstone Creek Culvert include a downstream headwall with wing walls, an upstream headwall and retaining wall, and a red brick-lined barrel arch. The downstream headwall is faced with irregularly coursed rough-cut granite; the interior of the arch is lined with red brick. The parapet retains some of the flat machine cut capstone slabs. The upstream headwall is irregularly coursed rough-cut granite; the interior of the arch is lined with brick and parged. The parapet on the downstream side was capped with large hand beveled stone slabs.

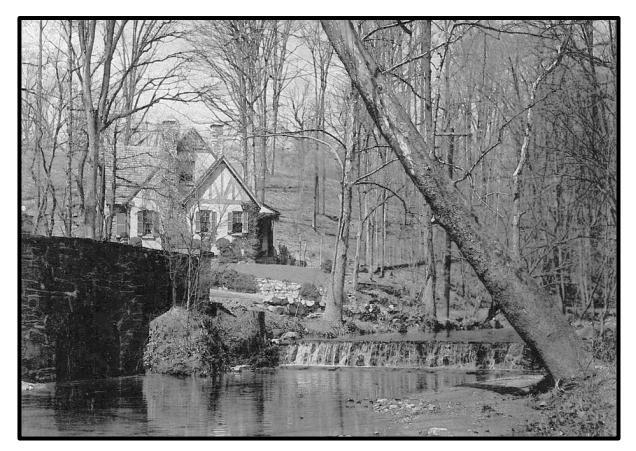
Figure 3-9. Pre-1934 Photograph of the Soapstone Creek Culvert (downstream side) without the Wing Walls (E. B. Thompson, DC Public Library Photo Archives)

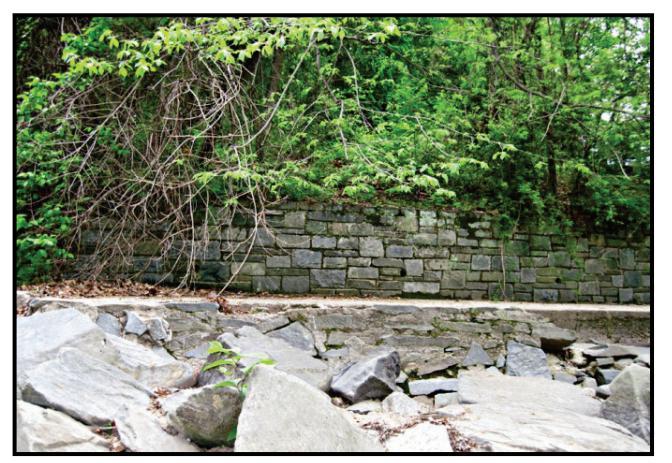
Figure 3-10. Mortared Ashlar Stone Wall with Concrete Spillway south of Broad Branch Road Bridge

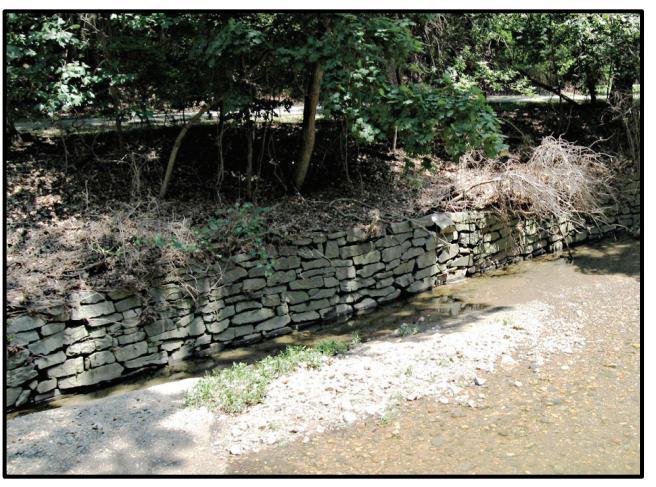
The fifteen segments of retaining wall that were identified as contributing elements appear to be dry laid with rough cut stone in regular courses (**Figure 3-11**).

Observable courses vary by segment with many portions of the wall segments collapsed into Broad Branch stream. No evidence of mortar could be observed on collapsed stones in the stream. These segments may represent the remains of a once continuous stone retaining wall along Broad Branch Road.

Figure 3-11. Dry Laid Rough-cut Stone in Regular Courses (large block) between the Broad Branch Road and Ridge Road Bridges

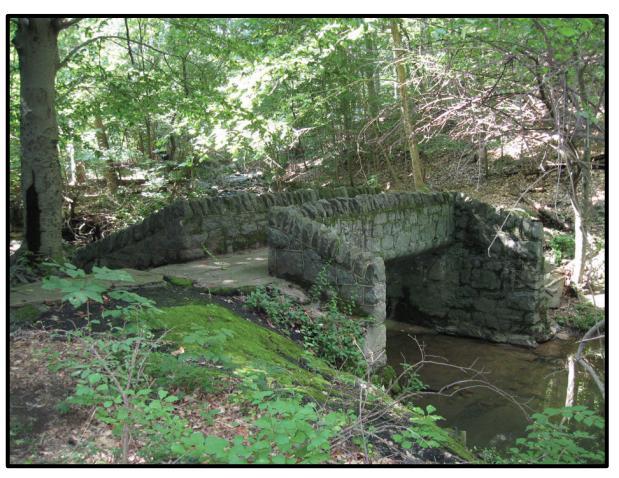
A stone footbridge is located within the DDOT right-of-way past the north end of the Rock Creek Park boundary **(Figure 3-13)** adjacent to the Civil War Fort Sites and Fort Circle Park System Historic District and US Reservation 515. The stone footbridge has irregularly coursed stone headwalls, wing walls, and abutments. The bridge deck is concrete. The parapets are crenellated, and the mortar joints are beaded.

Originally, a wooden bridge crossed Broad Branch at this location (DC WASA, 1983a) which was later replaced with the stone pedestrian bridge and encased a 12-inch diameter sewer pipe. Based on the DC WASA counter map IK-23-24-NW (DC WASA, 1983a), this portion of the sewer line was abandoned in 1966.

Figure 3-13. Stone Pedestrian Bridge over Broad Branch stream

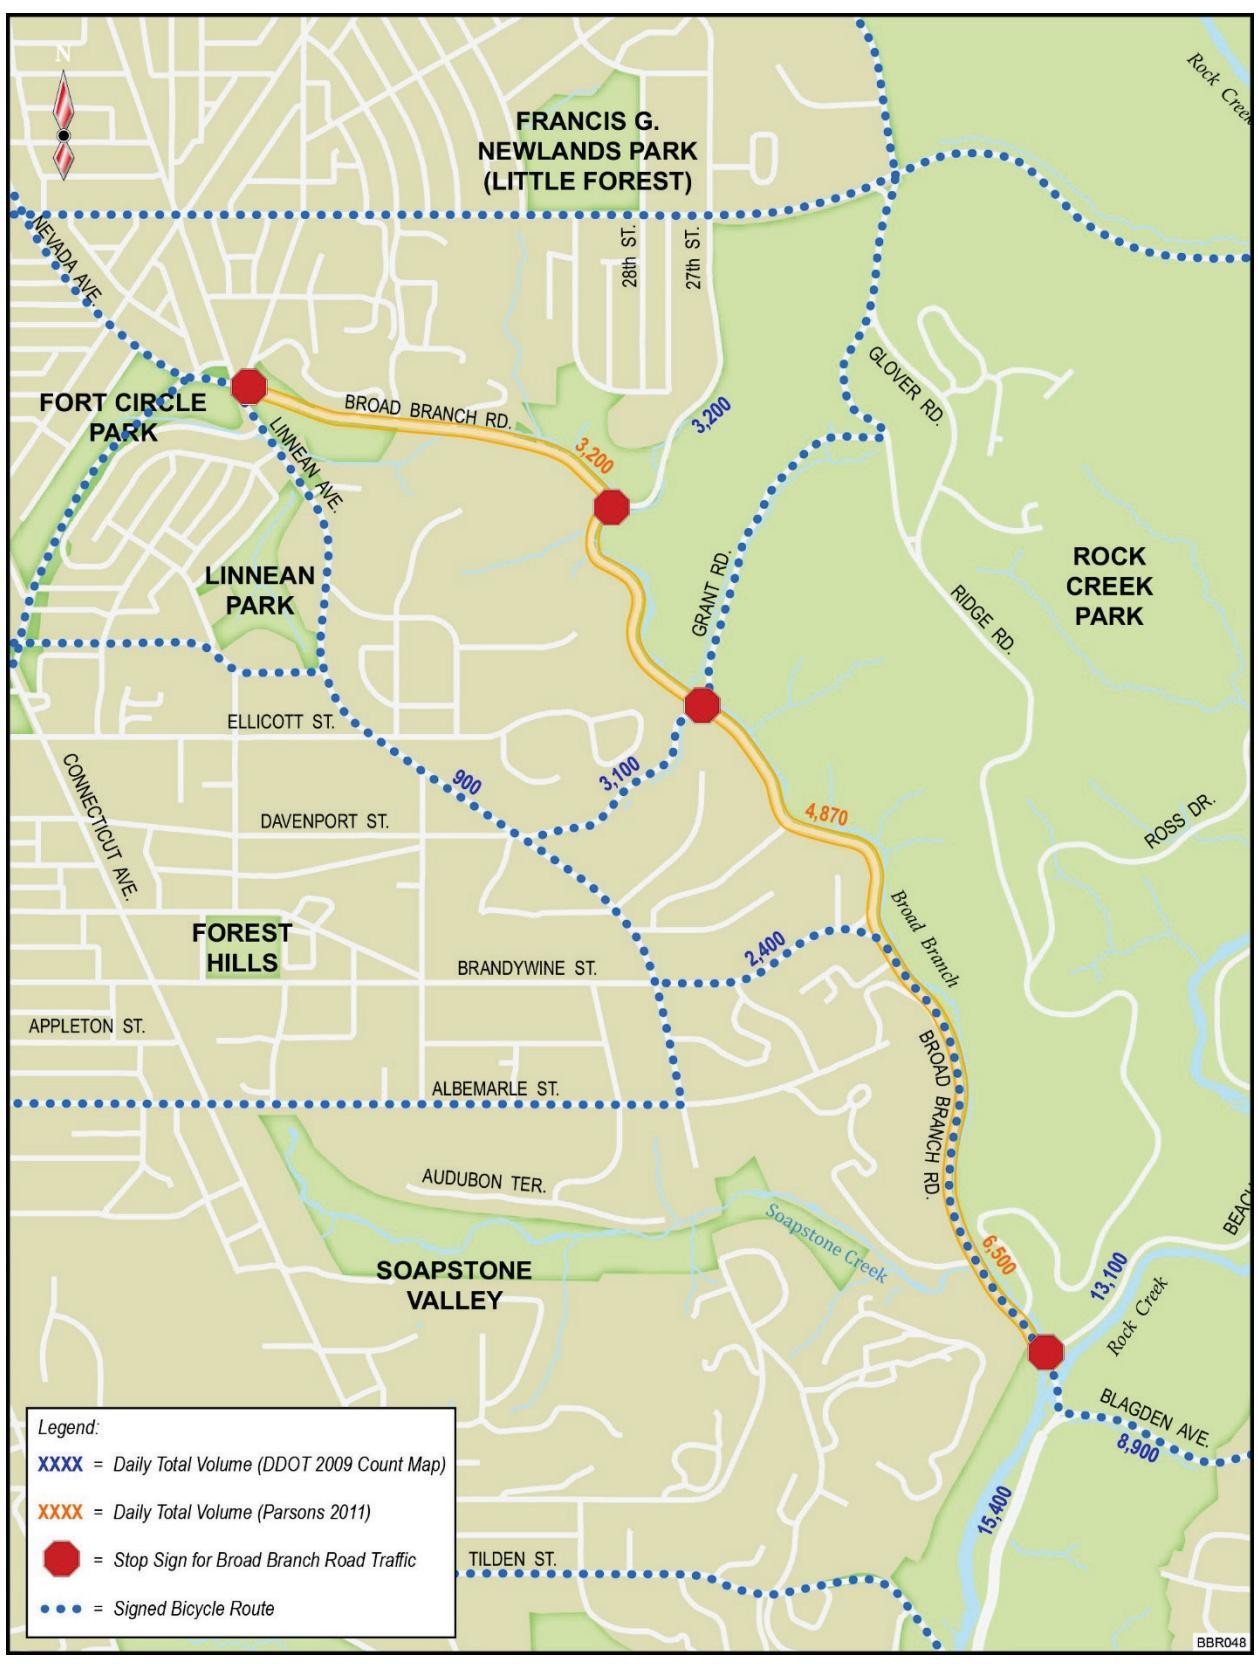
Figure 3-19. Traffic/Roadway Features

Each of the elements of the transportation system – pedestrian and bicycle facilities, the roadway network, and transit services – is described in the subsections below (**Figure 3-19**).

A review of the traffic volumes suggests that there is adequate capacity in the existing roadway network; therefore, capacity improvements are not recommended as part of the Broad Branch Road improvements. As shown in Figure 3-19, existing traffic volumes are more than two times heavier at the southern end of Broad Branch Road because this section of the corridor collects commuter traffic from the adjacent neighborhoods to locations east of Rock Creek Park. The higher traffic volumes on this section, combined with the lack of space or adequate facilities for pedestrians and cyclists, present a growing safety problem in the entire roadway corridor. The Beach Drive/Blagden Avenue intersection operates at level of service (LOS) F in both the morning and evening peak hours due to turning movements associated with commuter traffic traveling to and from downtown Washington, DC.² The same holds true for the intersection with Grant Road/Davenport Street in the morning peak period, during which eastbound traffic experiences high levels of delay to turn onto Broad Branch Road.
