1 PURPOSE AND NEED

This Revised Draft Environmental Assessment (EA) expands upon the discussions presented in the initial EA published on October 9, 2013. This revised EA further documents the analysis of a range of alternatives for improvements to the operations and safety of the roadway and the selection of the Preferred Alternative. The alternatives considered were consistent with the project setting and addressed deficiencies in the existing roadway infrastructure and stormwater management systems outside the existing DDOT right-of-way; improved the safety of motorists, pedestrians, and bicyclists; and enhanced linkages that serve pedestrian and bicycle travel. Project goals were to minimize roadway elements that occur outside the existing DDOT-owned right-of-way.

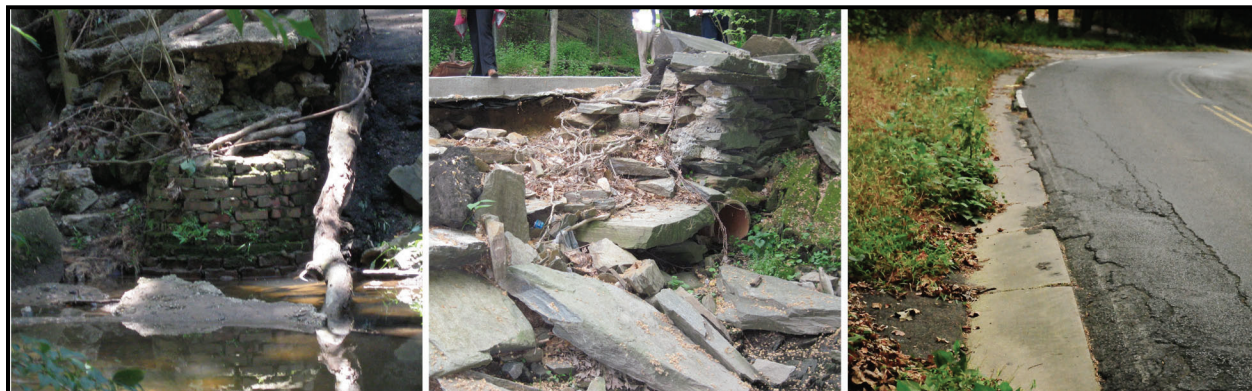
Figure 1-2. Deteriorated Infrastructure along Broad Branch Road

The existing Broad Branch Road roadway pavement is deteriorated and crumbling in many locations (see **Figure 1-2**), a problem exacerbated by stormwater drainage issues. The existing roadway has an apparent failed base, inadequate pavement, and roadway width less than required by current roadway design standards. Concrete curb is provided sporadically along the roadway and has been infilled with asphalt in some sections. The pictures in Figure 1-2 illustrate the deteriorating pavement, side-slope erosion, steep roadway slopes, and the impact of ponding runoff due to inadequate stormwater management.

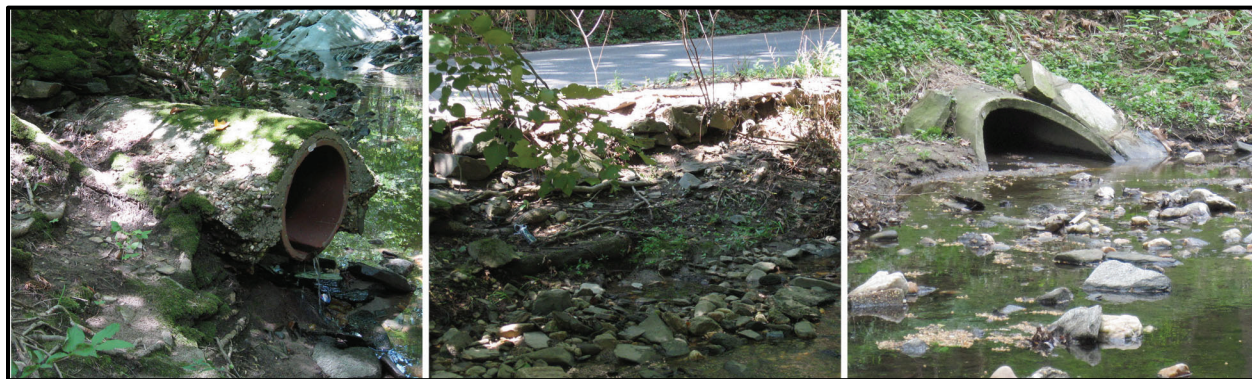
Figure 1-3. Examples of Drainage Issues

the existing storm drain system, where available, and discharged into Broad Branch. The roadway drainage system consists of inlets in the areas where there are existing storm sewer systems and these discharge into Broad Branch in Rock Creek Park via 21 existing outfalls, including both piped channels and low points along the roadway. A review of current conditions indicates that most of the inlets along the roadway are of inadequate capacity to capture combined runoff from the roadway and offsite areas. As a result, significant amounts of stormwater runoff bypass the inlets and sheet flow over the road and directly into Broad Branch. The lack of existing stormwater management facilities in the project area means that runoff from the roadway and offsite areas discharges into Broad Branch without any water quality treatment. This uncontrolled runoff has also contributed in large part to the deterioration of the roadway, the stream banks of Broad Branch, and retaining walls adjacent to Broad Branch Road. The current conditions are unsafe because of these drainage issues; the lack of adequate stormwater management combined with the topography results in areas along the roadway where ponding often occurs. **Figure 1-3** illustrates deteriorated conditions caused by stormwater runoff within the roadway corridor.

The uncontrolled runoff from elevated parcels to the north and west of the roadway has contributed in large part to the deterioration of this two-lane roadway. The large volume of stormwater has also had detrimental effects on the adjacent streambeds in Broad Branch and

Soapstone Creek. Extensive erosion at outfalls as well as at streambeds of the receiving waterways has been attributed to the high, erosive powers of the stormwater. The need for a total solution involving improvements on National Park properties has resulted in NPS serving as a Cooperating Agency in the development of this EA. Other notable environmental issues associated with this project include Section 106 (cultural resources), Section 4(f) resources (cultural resources and parklands), habitat concerns (fish and wildlife), water quality, and residential concerns (noise and visual intrusion and bike/pedestrian safety).

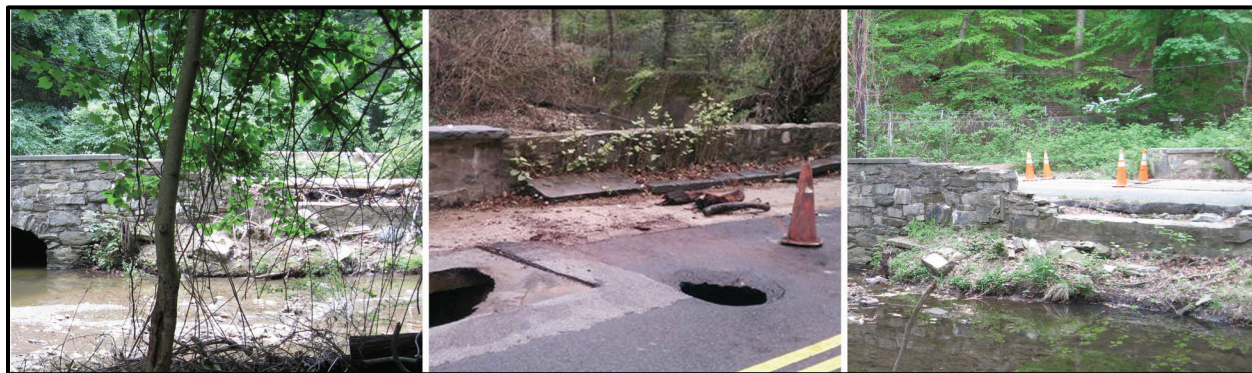
Figure 1-4. Soapstone Creek Culvert

Broad Branch Road crosses over Soapstone Creek on a single stone masonry semicircular arch culvert that is aging and substandard in terms of condition and its ability to convey floodwaters from major periodic storms (see **Figure 1-4**).

An inspection of the culvert conducted in 2003 found the structure to be in generally satisfactory condition; however, deficiencies included collapsed headwall capping stones, poorly placed manhole cover grates, accumulated debris at the inlet (west side), collapsed stone retaining/wing walls on the east, non-standard cable wire guardrails, channel scour in the arch barrel, need for upstream channel bank stabilization to prevent overflow, and non-standard masonry parapet for crash protection (Wilbur Smith Associates, 2003). After numerous flooding episodes, a major storm event in April 2011 resulted in sinkholes in the roadway surface and a partial collapse of the arch (see Figure 1-4). DDOT took immediate measures to prevent further damage to the structure by covering the roadway holes with steel plates, installing a temporary bridging platform to permit one lane of travel over the culvert, and implementing temporary structural repair to the culvert that included installation of a corrugated steel lining to stabilize the arch barrel.

Aging infrastructure has contributed to the deficiencies in the roadway corridor. The culvert carrying Broad Branch Road over Soapstone Creek has been temporarily repaired after partial collapse and requires permanent replacement. Replacement of this culvert will be addressed as a part of the upgrades planned for Broad Branch Road.

In the Broad Branch Road project area, an 18-inch diameter sanitary sewer line parallels the south side of Soapstone Creek ending about 20 feet from Broad Branch Road where a manhole marks the location of a split in the lines. A 21-inch diameter pipe extends southeast under Broad Branch Road, accessible from another manhole in the roadway, and an 18-inch pipe extends northeast under the Soapstone Creek streambed, the existing west headwall of the Soapstone Creek Culvert, and to another manhole along the eastern edge of Broad Branch Road.

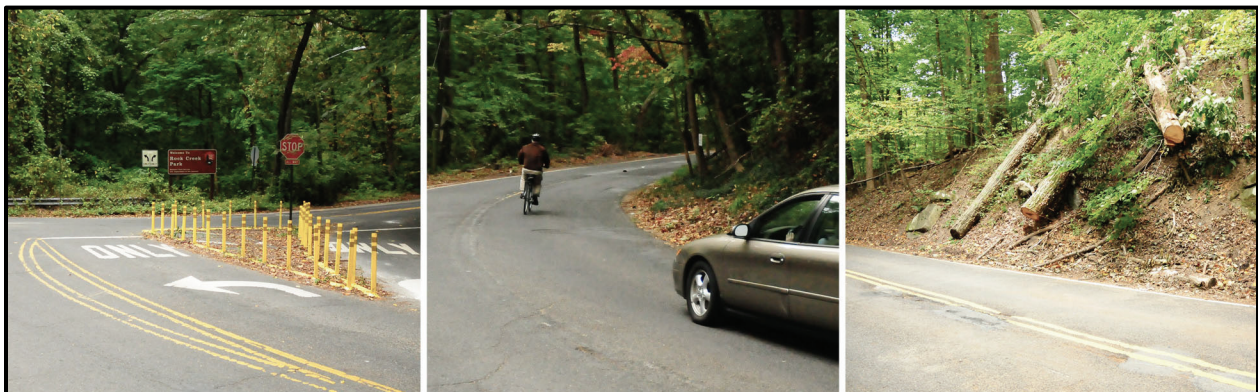
Figure 1-5. Existing Roadway

Broad Branch Road is a two-lane roadway located in northwest Washington, DC. The portion of Broad Branch Road in the identified project area extends south from Linnean Avenue to just north of Beach Drive, a distance of approximately 1.5 miles. For much of its length, the roadway parallels the channel of Broad Branch. The approximately 170-acre Broad Branch watershed is a highly urbanized sub-watershed of Rock Creek. As shown in Figure 1-1, Rock Creek Park (owned by the federal government and administered by NPS) is located immediately east of Broad Branch Road south of 27th Street, which creates a wooded, rural-like setting for much of the project corridor, as shown in **Figure 1-5**. Rock Creek Park is one of the largest forested urban parks in the United States, nearly a mile wide in some places, and contains a wide variety of natural, historical, and recreational features in the midst of Washington, DC. It is this rural-like context within an otherwise urbanized area that residents suggest make this roadway unique.
