District Department of Transportation

Speed Limit and Safety Nexus Studies for Automated Enforcement Locations in the District of Columbia

1700 Block North Portal Drive NW

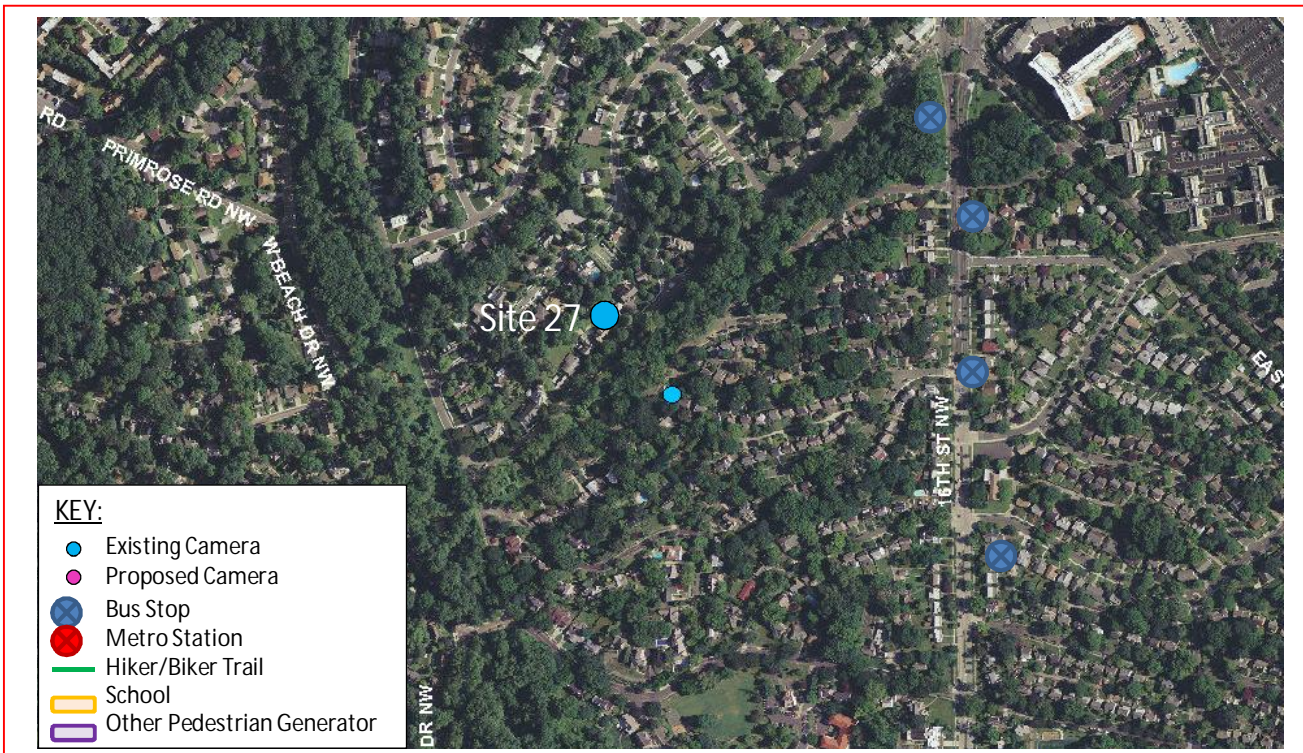
The existing speed camera is located in Ward 4 at the 1700 Block of North Portal Drive Northwest in the southwest-bound direction. This location is between the intersections of Birch Drive Northwest and East Beach Drive Northwest. North Portal Drive runs from 16th Street Northwest in the north to East Beach Drive Northwest in the south. The posted speed limit is 25 MPH. This speed camera was installed in August 2012.

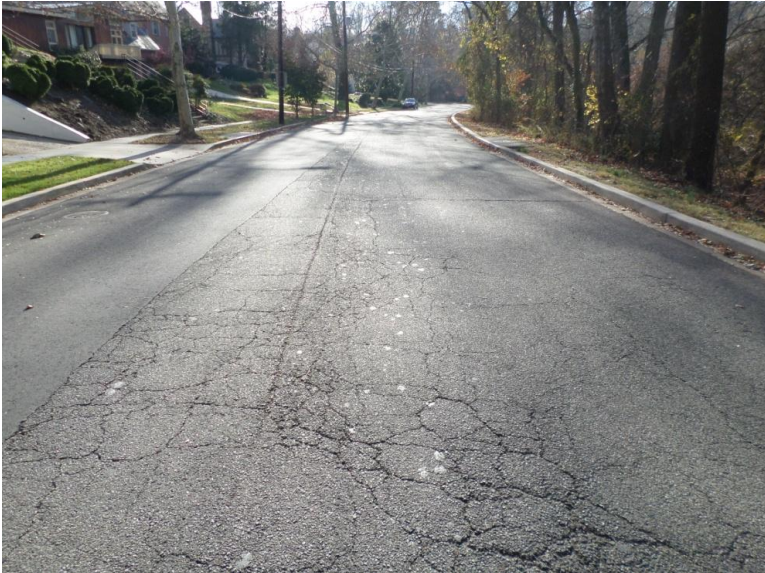
Looking Northbound

North Portal Drive NW is assumed to run in the North-South direction, and is classified as a collector. North Portal Drive Northwest is a bi-directional roadway with no centerline marking. It intersects Birch Drive NW and East Beach Drive NW. This site has the following characteristics:

- This site is located in a residential and wooded area with houses, driveways, and on-street parking on both sides of the street.
- The existing pavement is in good condition.
- There are stop signs and ramps at the intersections with Birch Drive and East Beach Drive.
- There are sidewalks with curb and gutter on the southwest side of the street.
